## BUILDING INSPECTION REPORT V1.0

62 Jamieson St  
Bulimba, QLD 4171

Alistair Cornish  
16/06/2026

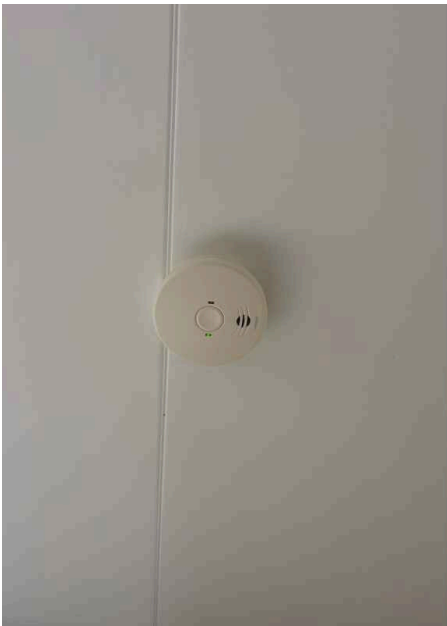
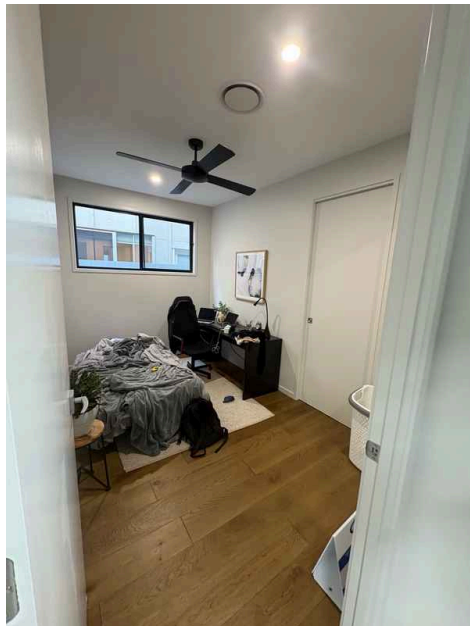
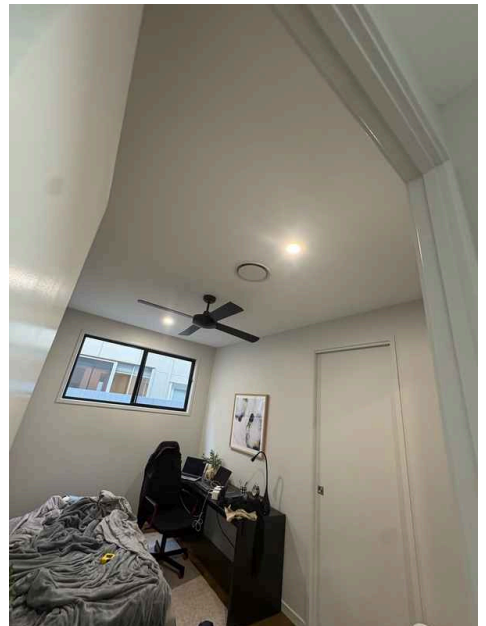
Ground Floor Bedroom 1

Smoke alarms appear to be missing from areas. Refer to 'Safety Hazards and Major Defects' for further recommendations

IMPORTANT NOTE: Testing of smoke alarms is not conducted during the course of this inspection. Recommend contacting a qualified smoke alarm technician or electrician to ensure compliance and correct operation.. Smoke alarms are critical safety devices designed to detect smoke from fires and alert occupants, providing early warning to evacuate. Regular testing and maintenance of these devices is important to ensure they function properly when needed.

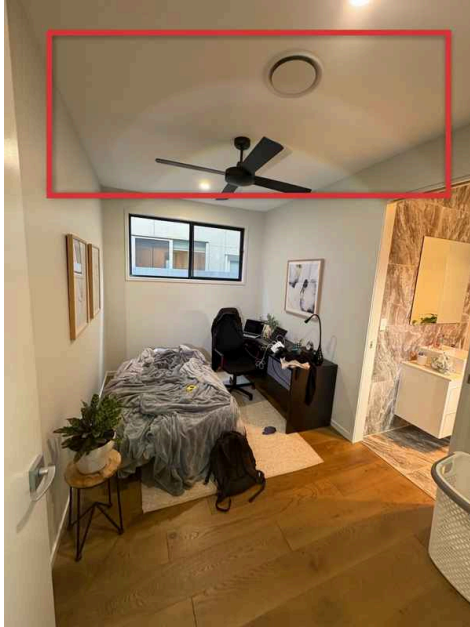
Ground Floor Bedroom 1

Smoke alarms missing

Smoke alarms are not observed to be fitted, non-compliant or deficient to parts of the property. This presents a risk of personal injury or possible death in the instance of a fire. Smoke alarms are not tested during this inspection.

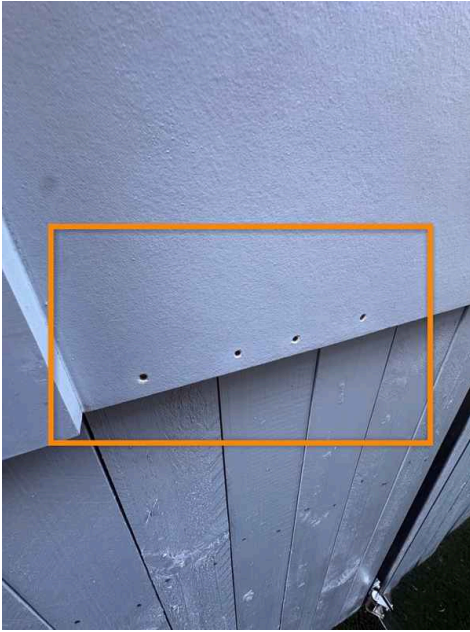
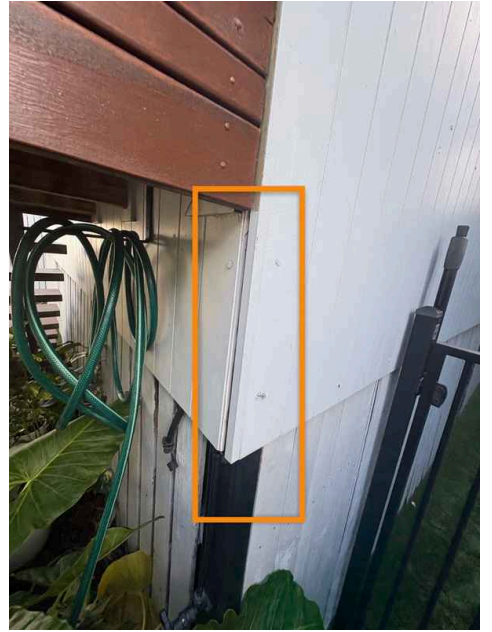
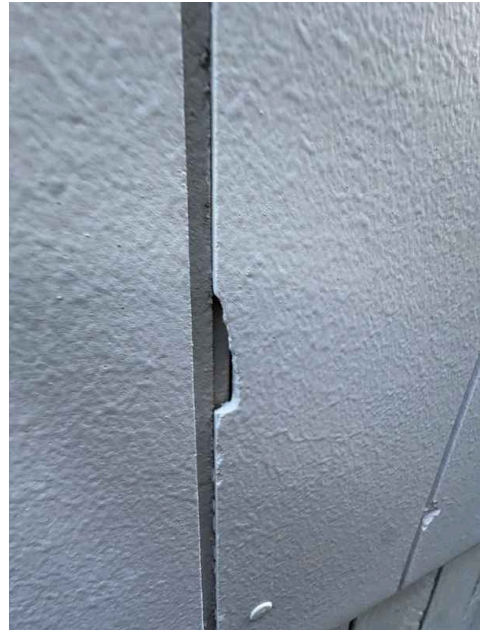
### 5.3.1 External walls

Gaps were observed along the exterior wall perimeter during inspection. These openings can allow water infiltration, pest entry, and air leakage into the home. Seal all gaps to prevent water ingress.

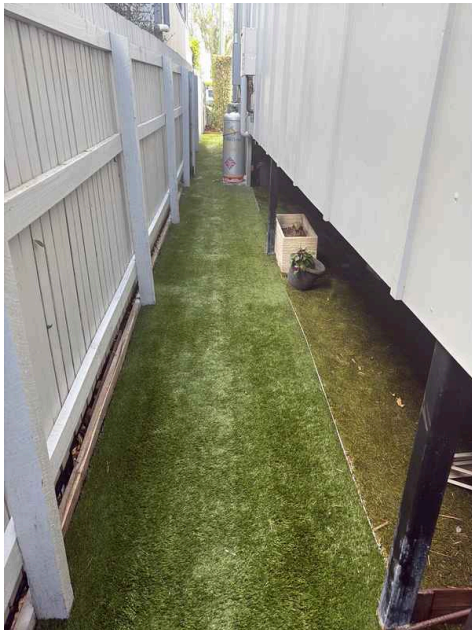
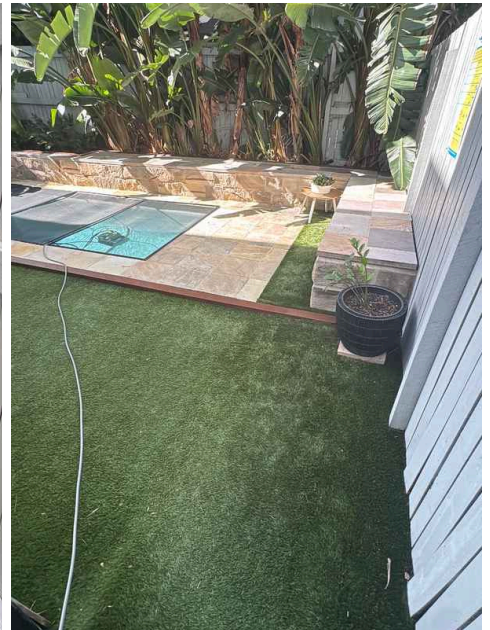
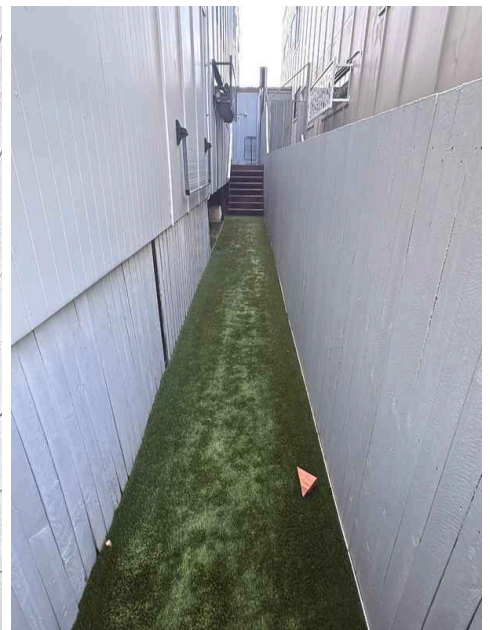
Poor surface drainage to areas where the ground or paving does not sufficiently slope away from the building. Recommend engaging a landscaper to rectify to reduce the risk of water ponding around, or inundating the building. This can lead to footing movement, deterioration of the building, other moisture related issues, This is also a conducive condition to timber pest attack. Please seek advice from a hydraulic engineer as discussed

Contact a qualified landscaping contractor

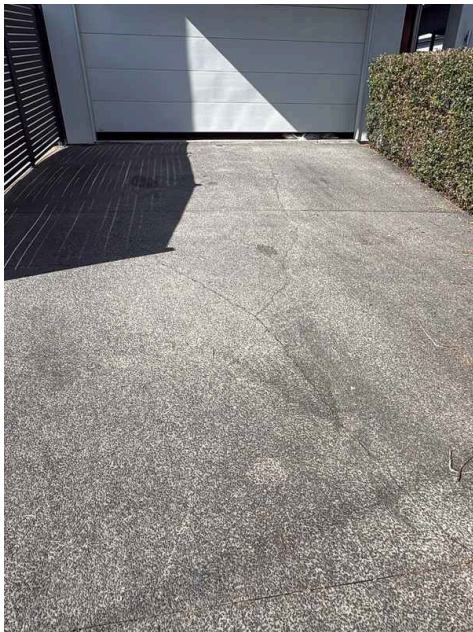
Ground Floor Front

## 5.13.2 Grounds/ Gardens

**CRACKING TO PATHS/ DRIVEWAYS/ PAVING (MAJOR)**

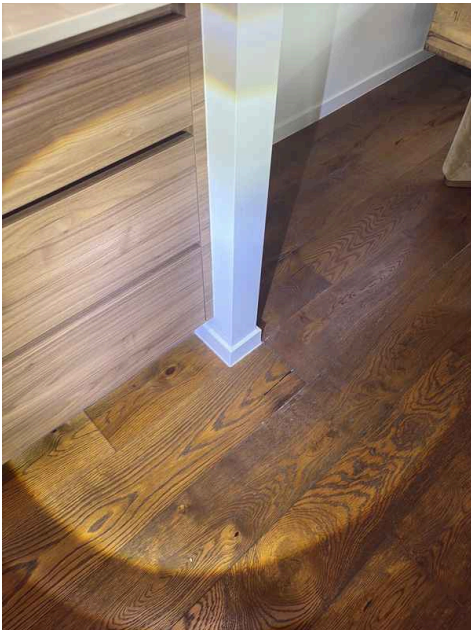
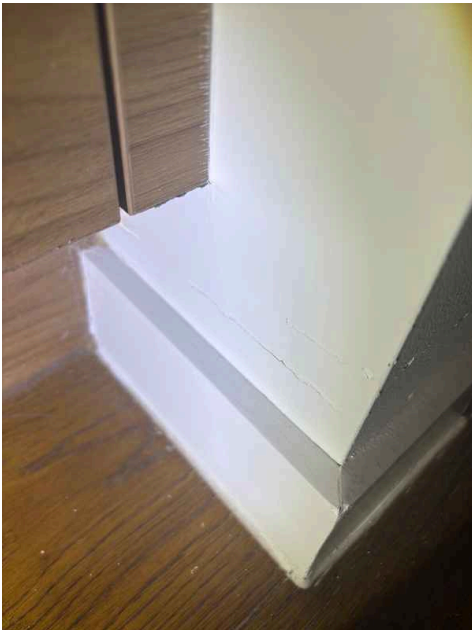
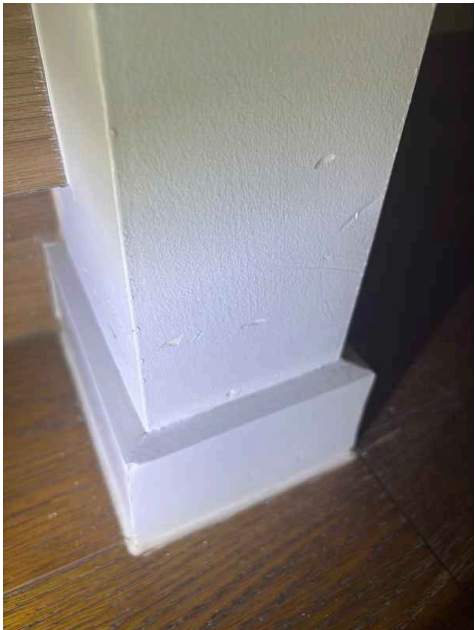
**GENERAL WEAR AND TEAR**

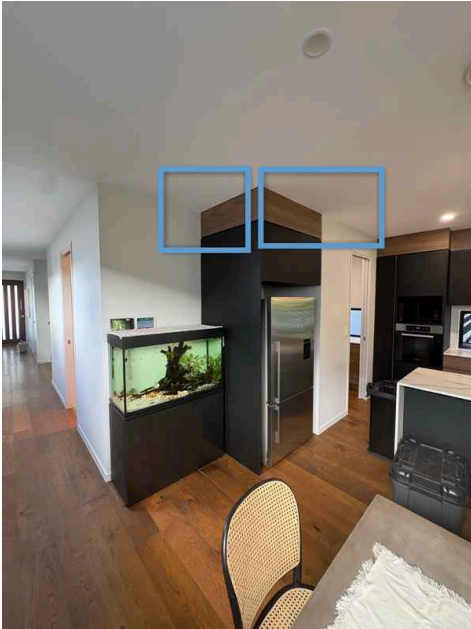
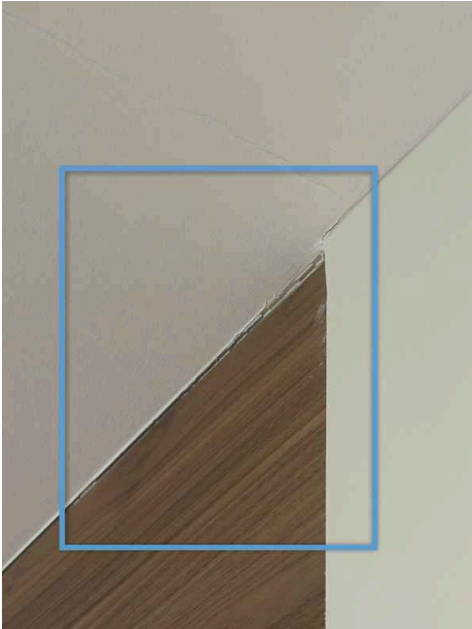
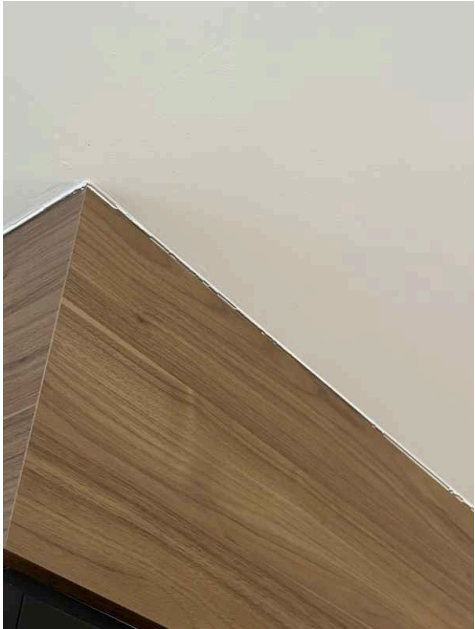
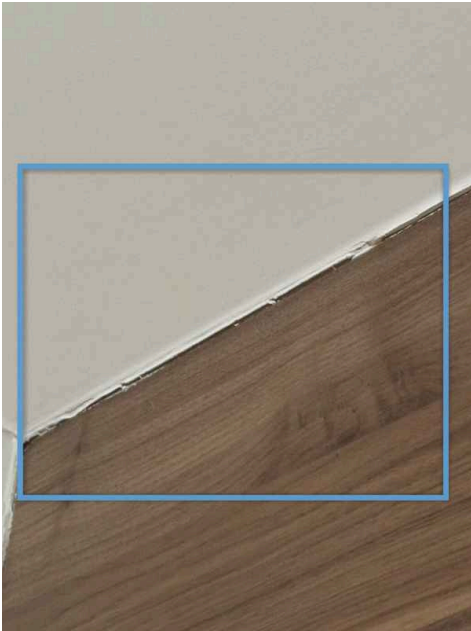
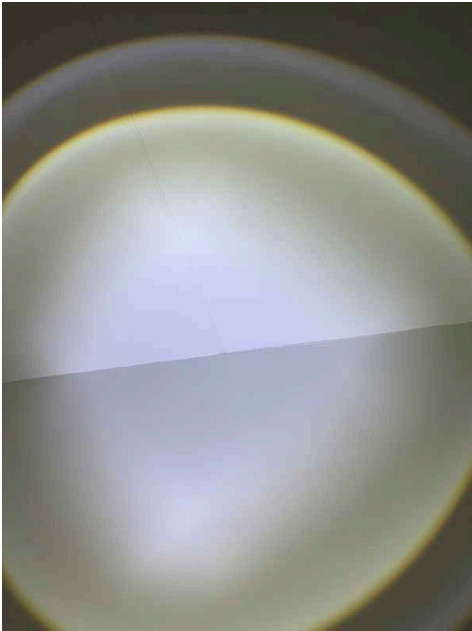
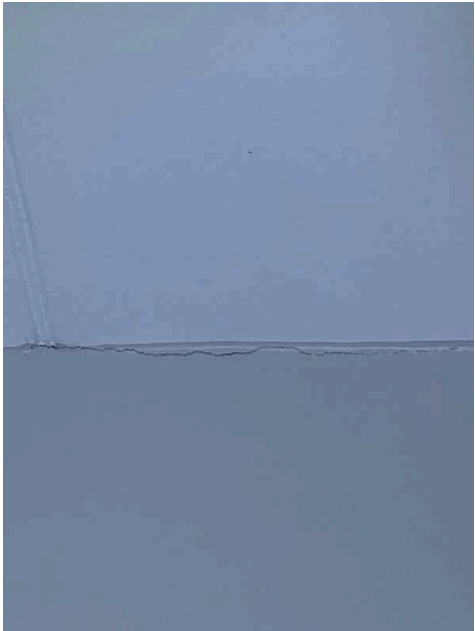
6.2.2 Walls

**MINOR CRACKING TO NON-STRUCTURAL ELEMENTS**

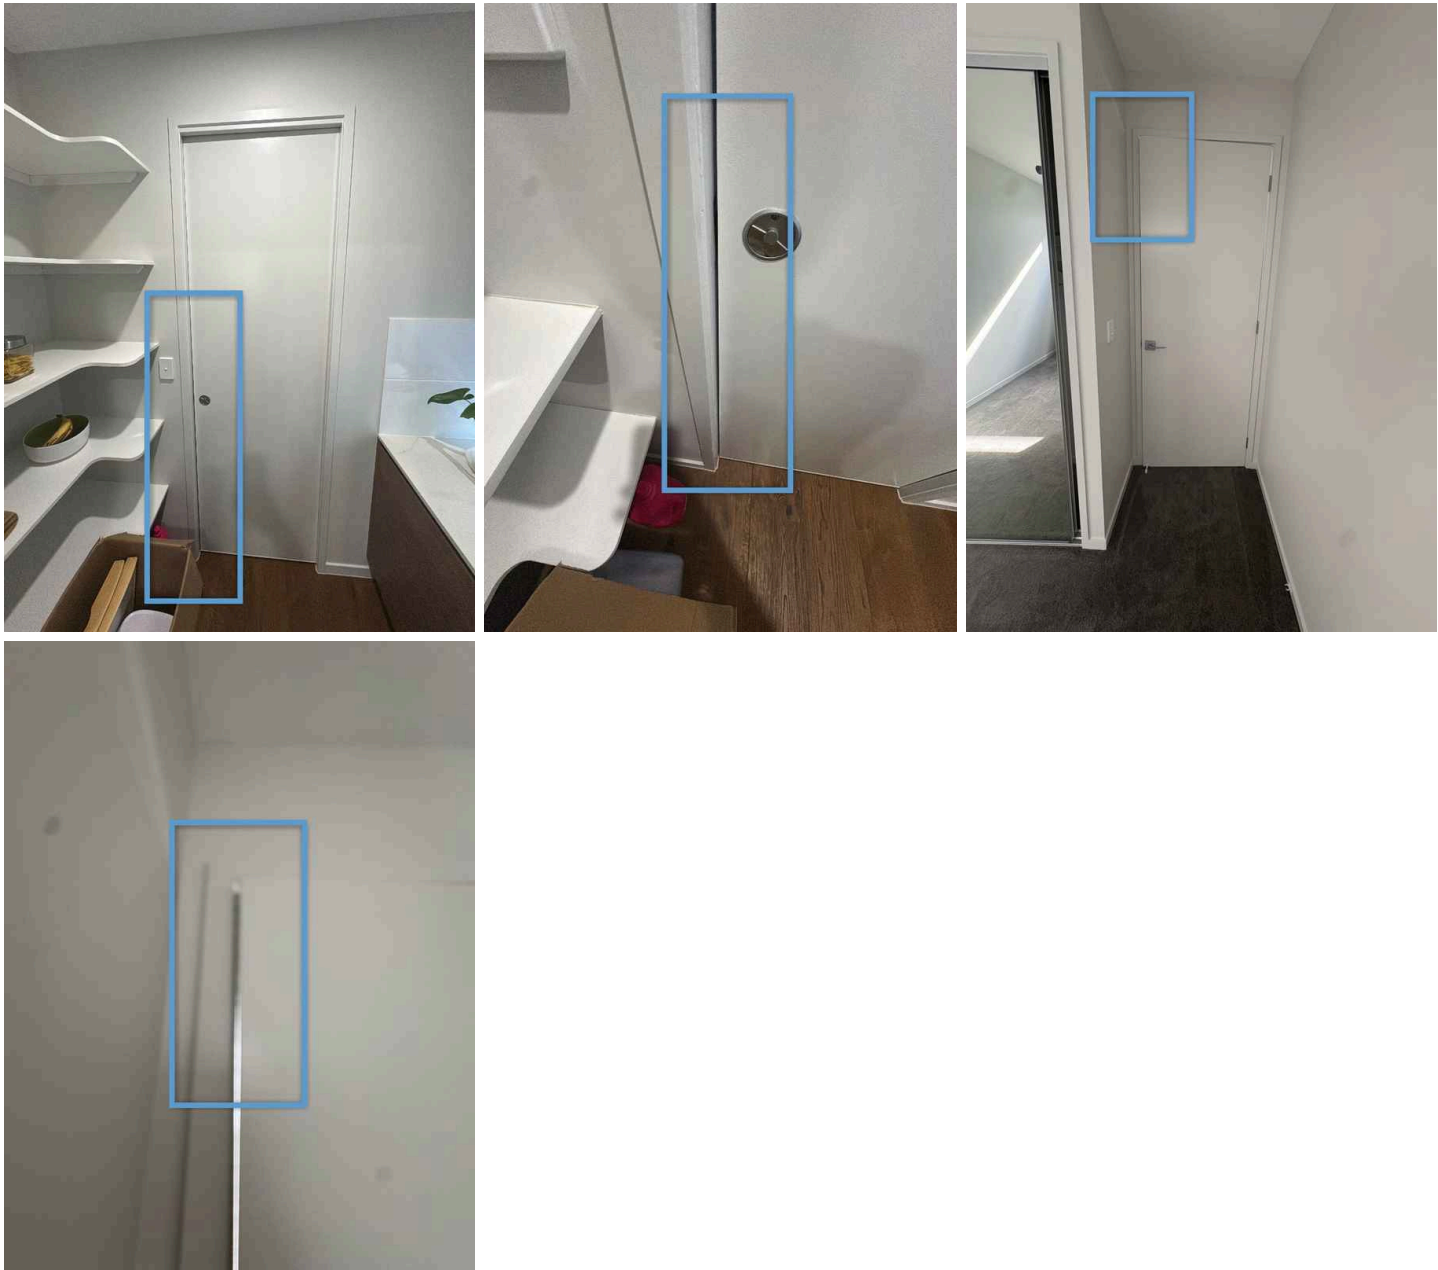
6.4.1 Windows and doors

**DOORS REQUIRE ADJUSTMENT FOR SMOOTH OPERATION**

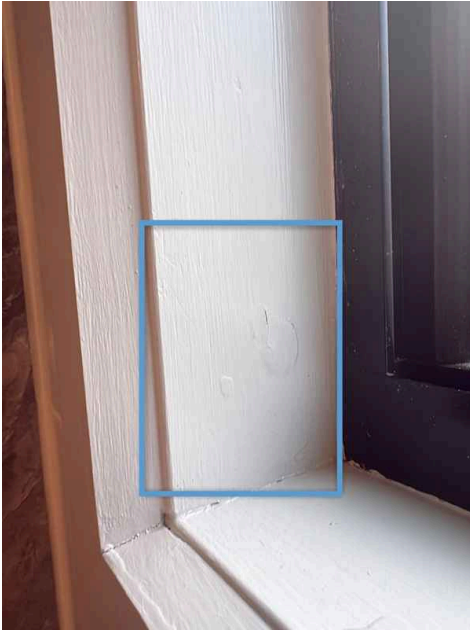
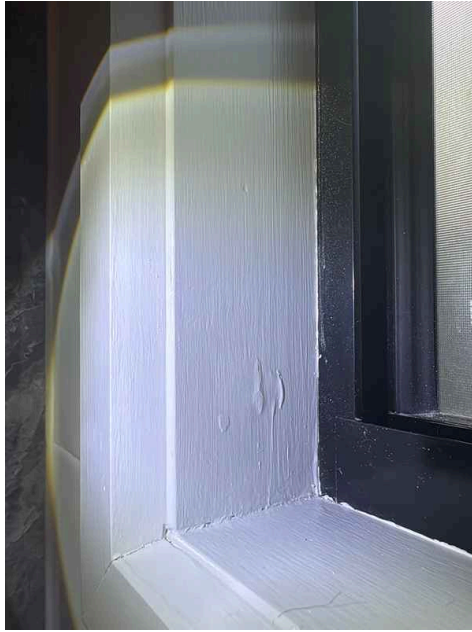
6.4.2 Windows and doors  
**MINOR DAMAGE OBSERVED**

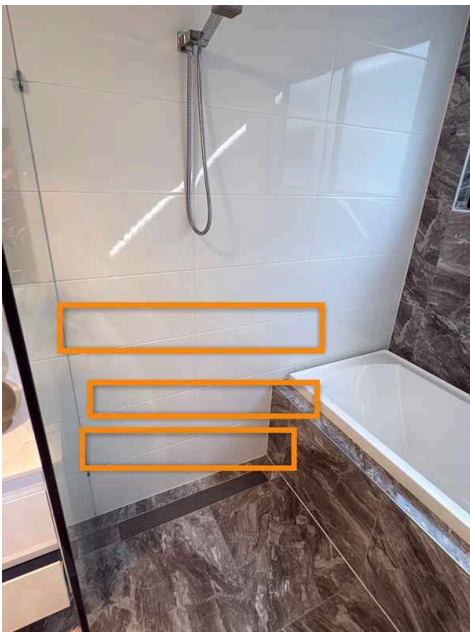
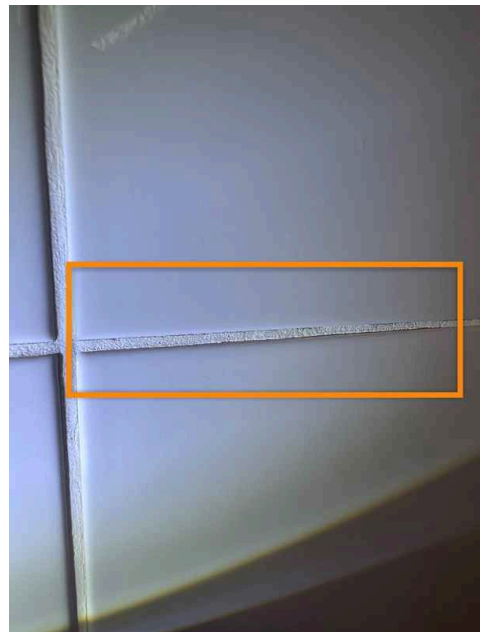
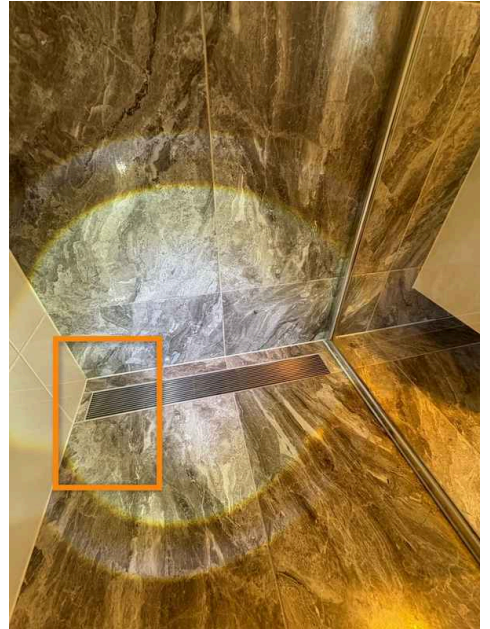
#### 6.8.1 Shower/Bath

### SEALANT/ GROUT REQUIRES REPAIR/ REPLACEMENT

The sealants and / or grout to wet areas require repair where they are incomplete, defective, or no sealant or grout is installed. Recommend engaging a tiler or builder to assess and rectify to reduce the risk of water penetration and further deterioration.

Contact a qualified tile contractor

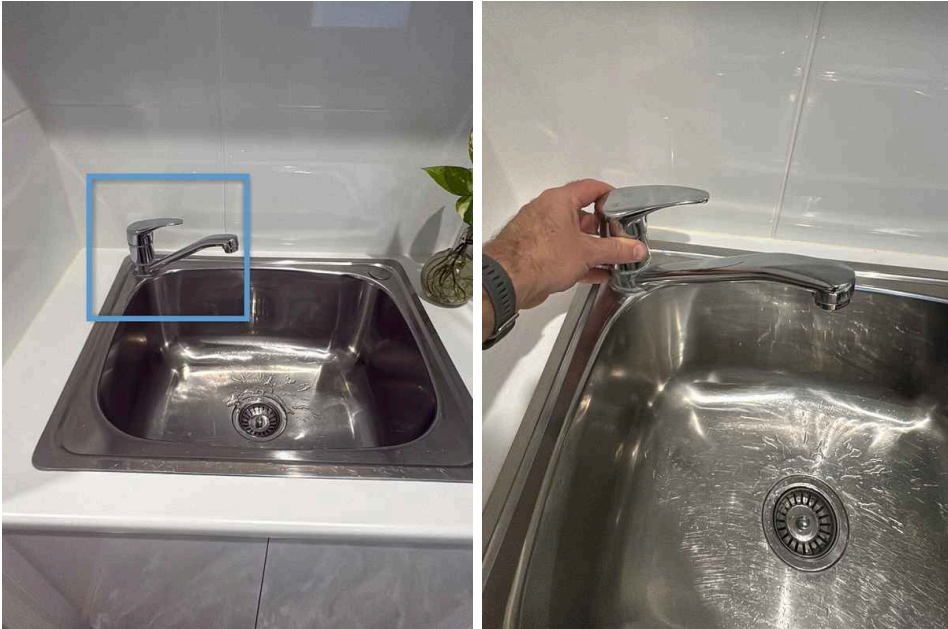
### LOOSE FIXTURES/ FITTINGS OBSERVED
