## BUILDING INSPECTION REPORT V1.0

62 Jamieson St  
Bulimba, QLD 4171

Alistair Cornish  
16/06/2026

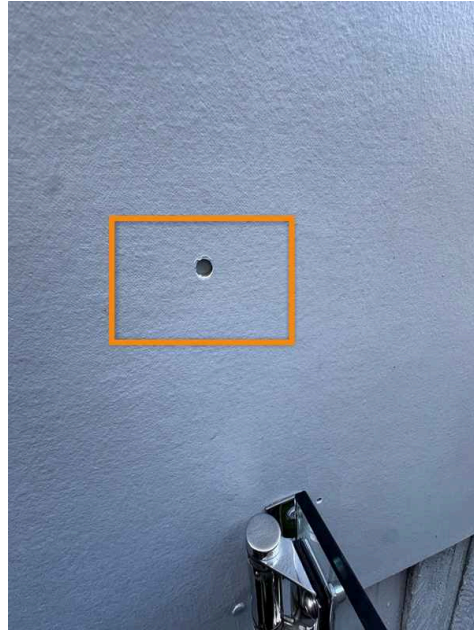
Ground Floor Rear

| Ref | Defect | Classification | Resolution |
|---|---|---|---|
| 5.3.1 | <b>External Walls:</b> Gaps to exterior walls | Major Defect | Repaired and resolved. |

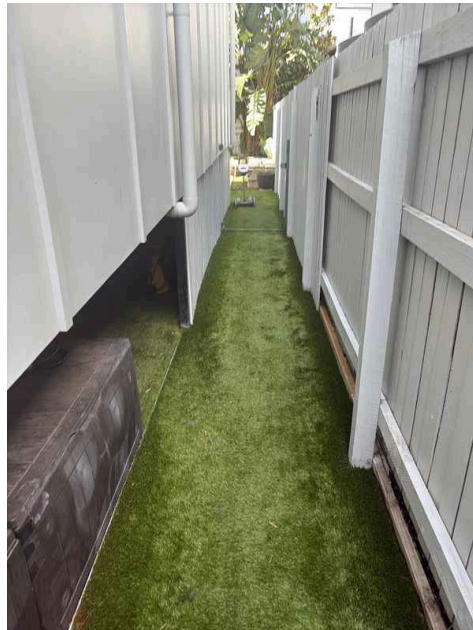
Ground Floor Right side

| Ref | Defect | Classification | Resolution |
|---|---|---|---|
| 5.13.1 | <b>Grounds/Gardens:</b> Poor surface drainage | Major Defect | The property has never experienced pooling in these areas. |

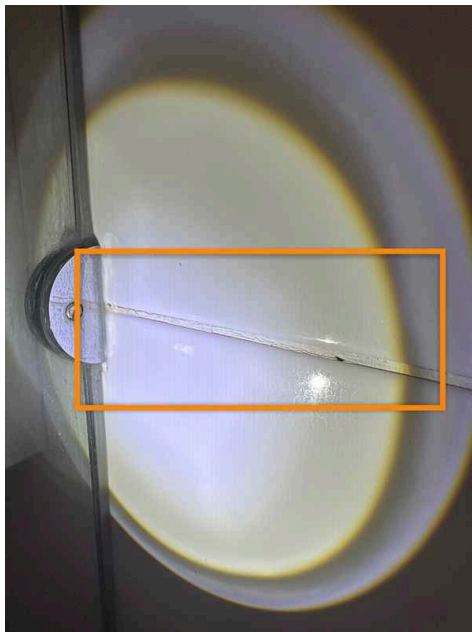
1st Floor Bathroom

### SEALANT/ GROUT REQUIRES REPAIR/ REPLACEMENT

The sealants and / or grout to wet areas require repair where they are incomplete, defective, or no sealant or grout is installed. Recommend engaging a tiler or builder to assess and rectify to reduce the risk of water penetration and further deterioration.

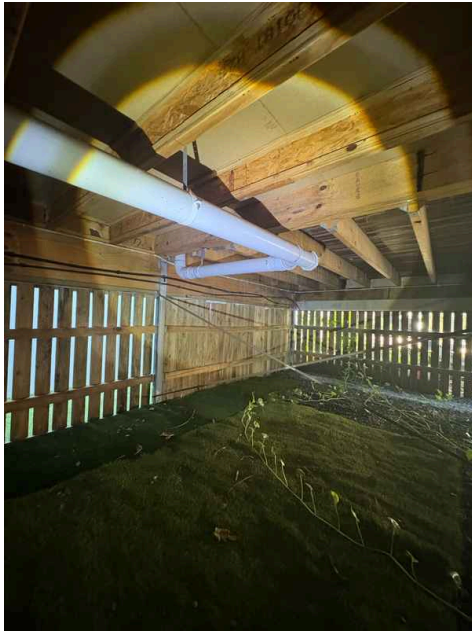
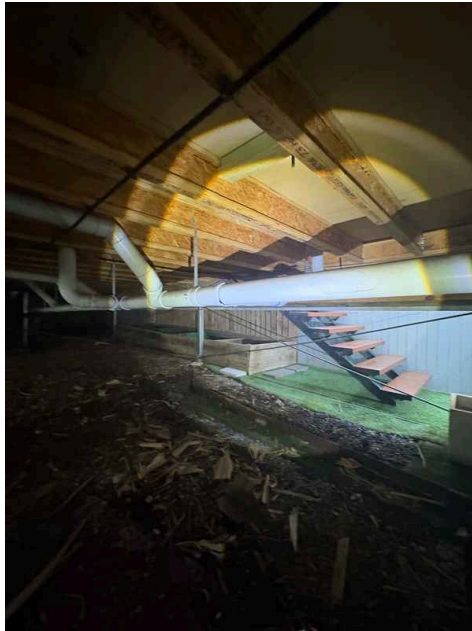
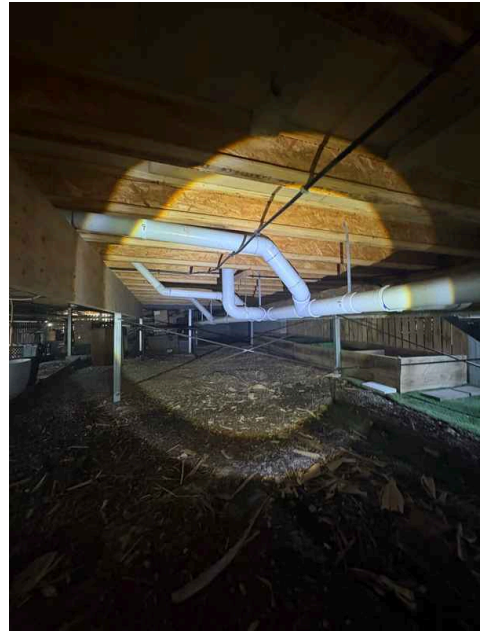
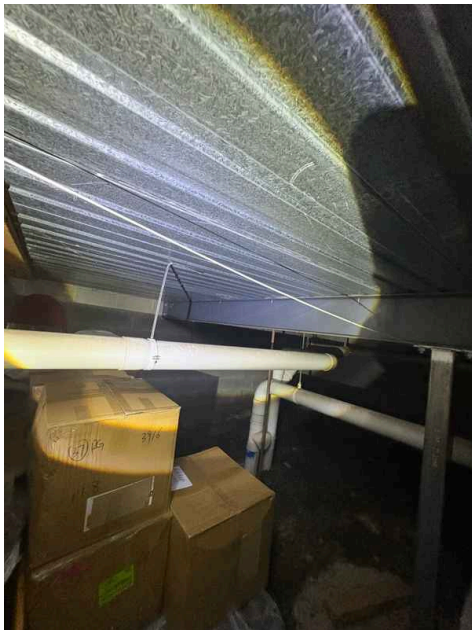
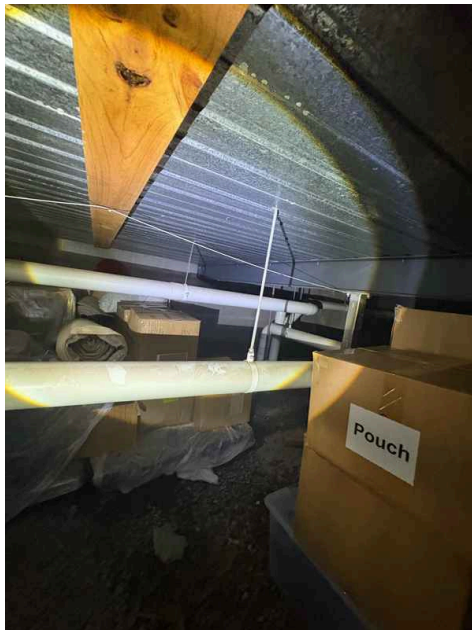
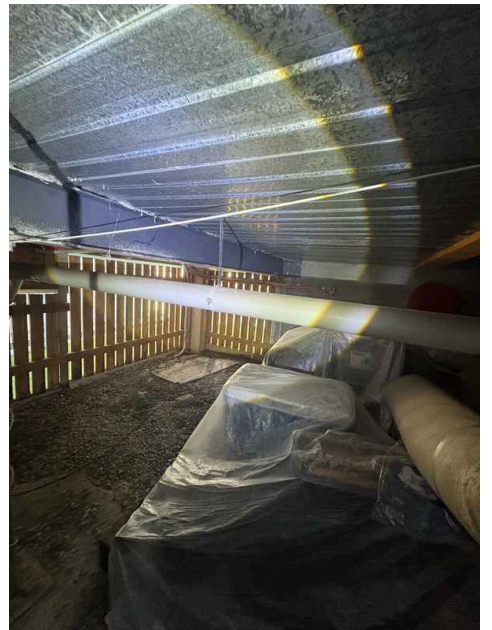
## SUB-FLOOR ACCESS WAS OBSTRUCTED AT TIME OF INSPECTION

Plumbing pipes

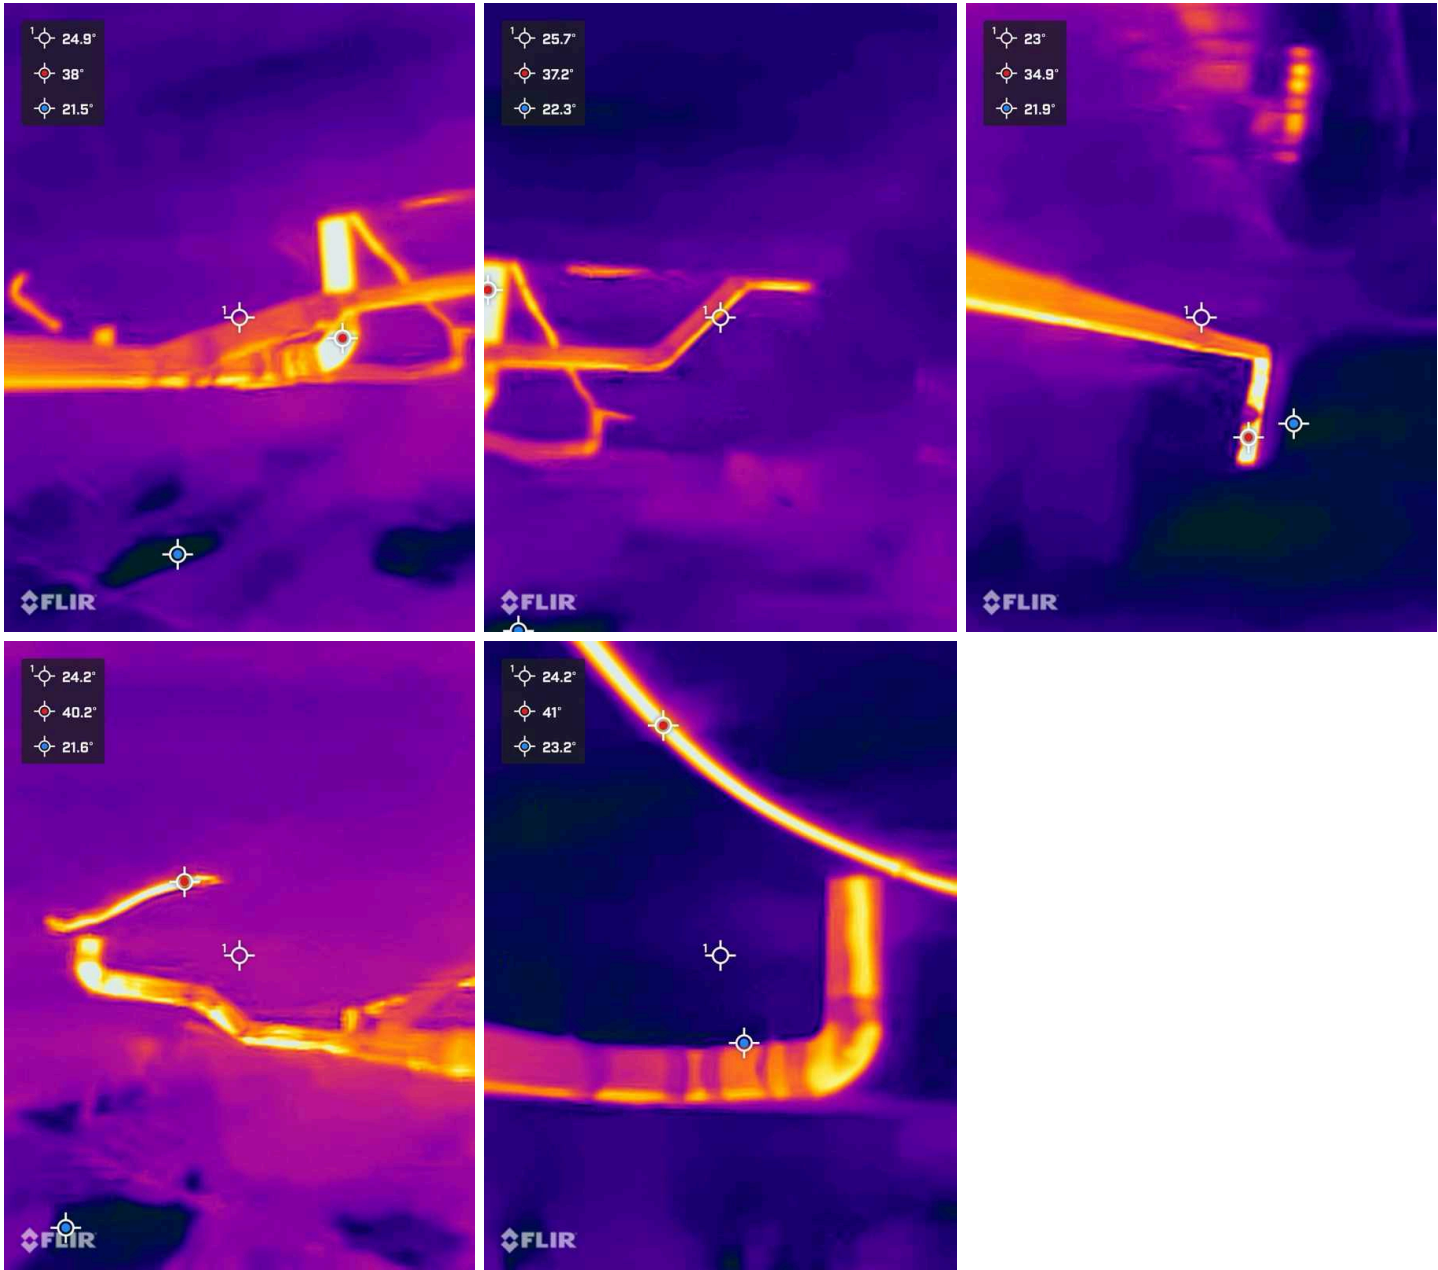
Subfloor photos, obstructions & inaccessible areas  
**INACCESSIBLE SUBFLOOR AREAS AT THE TIME OF INSPECTION**  
N/A

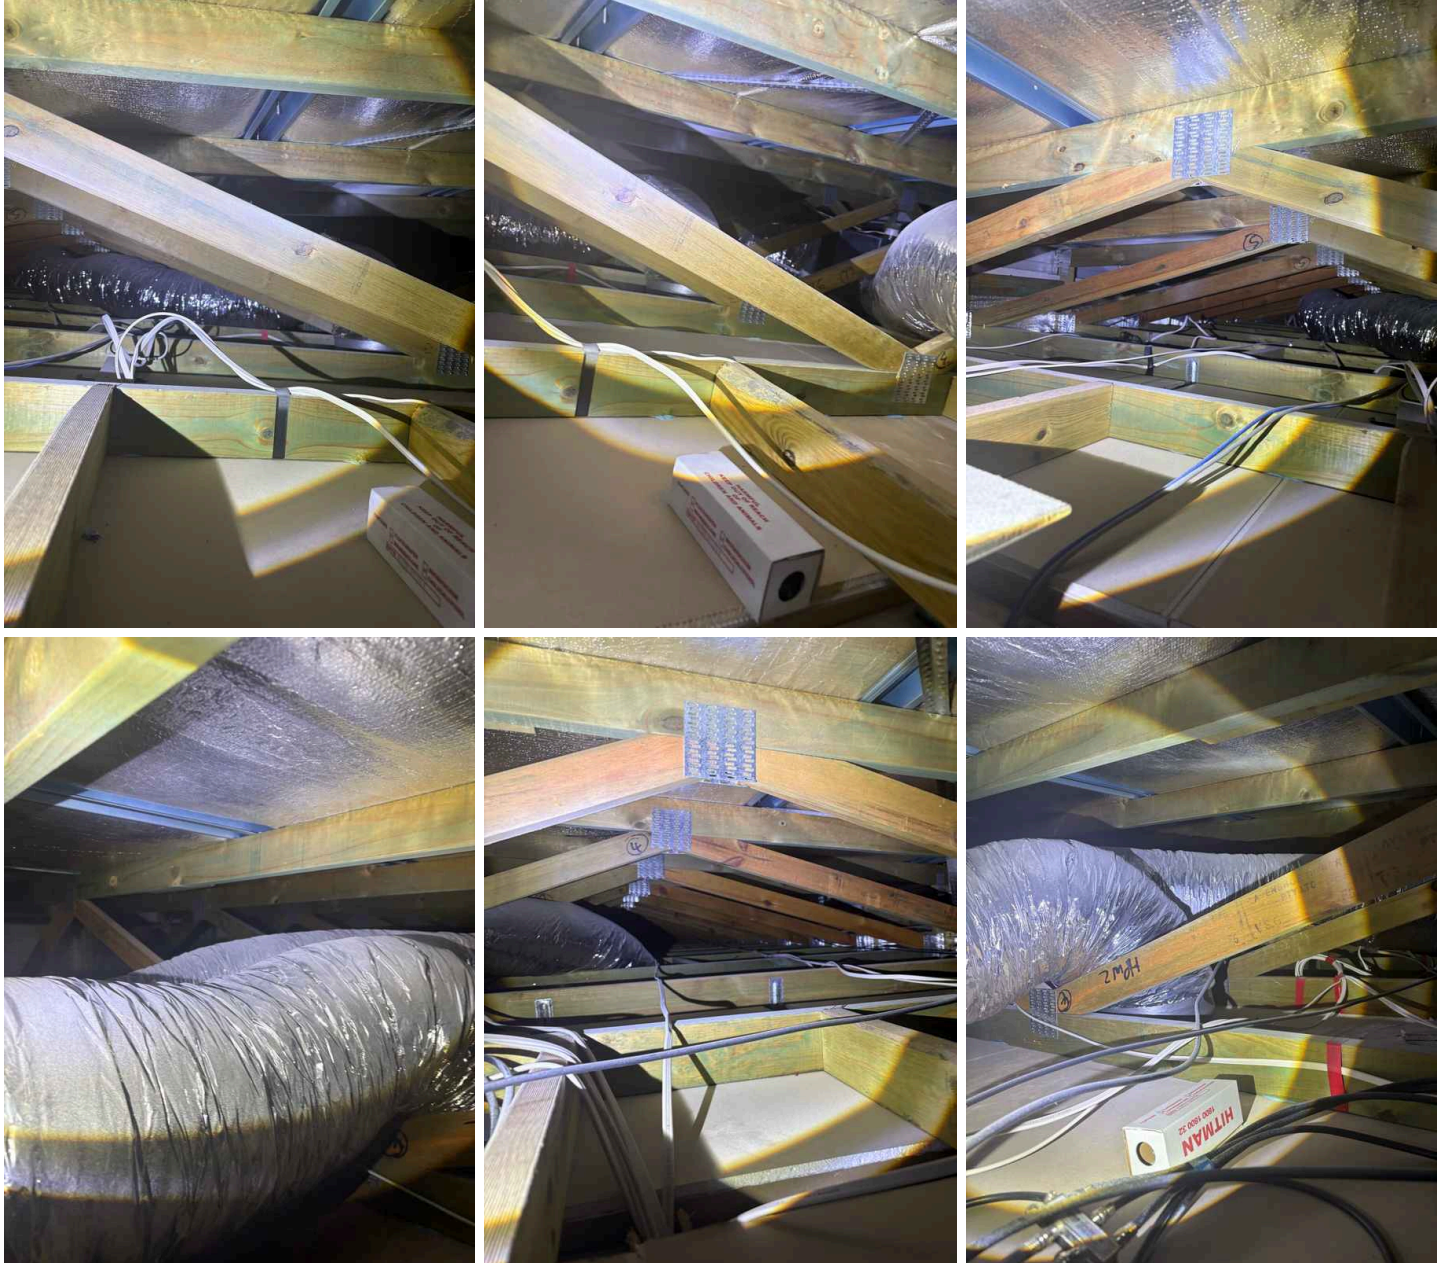
### ROOF SPACE ACCESS WAS OBSTRUCTED AT TIME OF INSPECTION

Low clearance to the outside edges of roof void, Ducting, Framing, Roof space inspected from a ladder at the manhole only

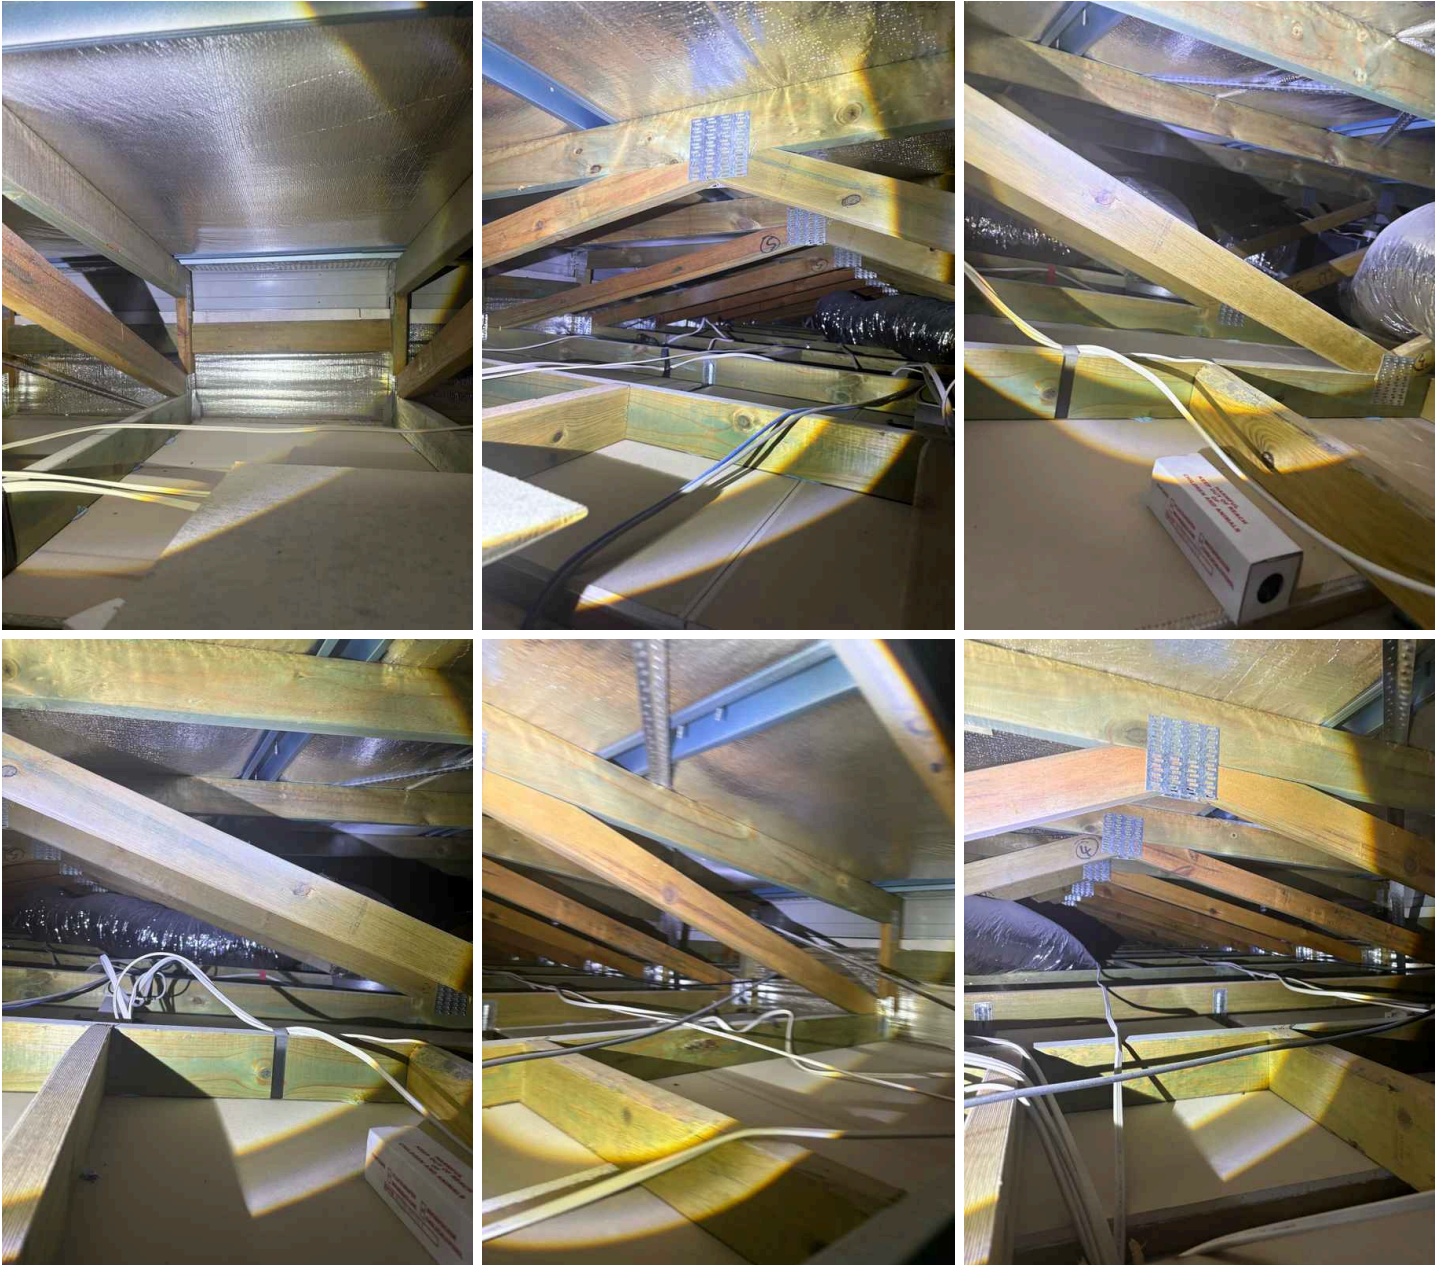
### INACCESSIBLE AREAS OF THE ROOF SPACE AT THE TIME OF INSPECTION

Insufficient crawl space

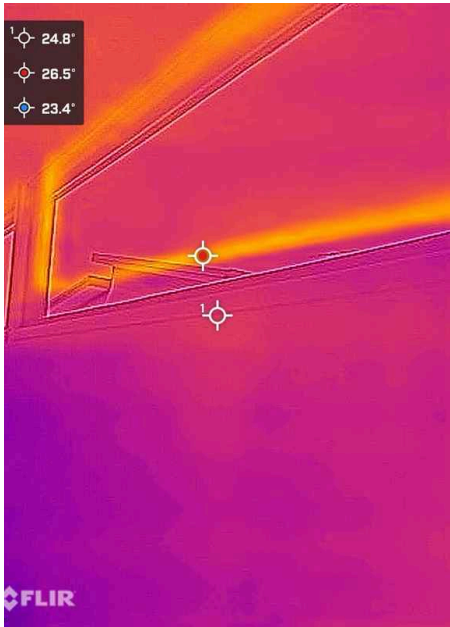
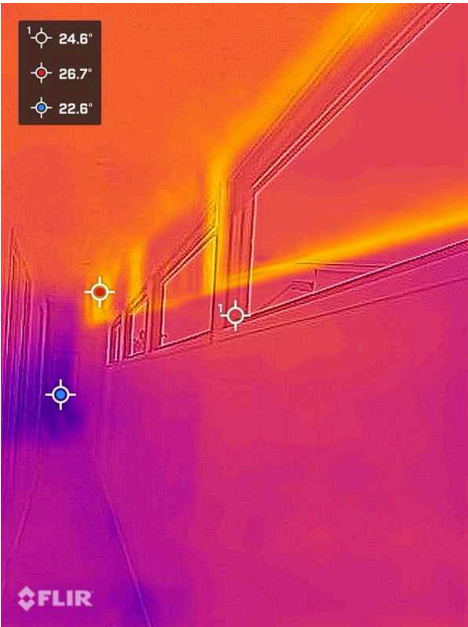
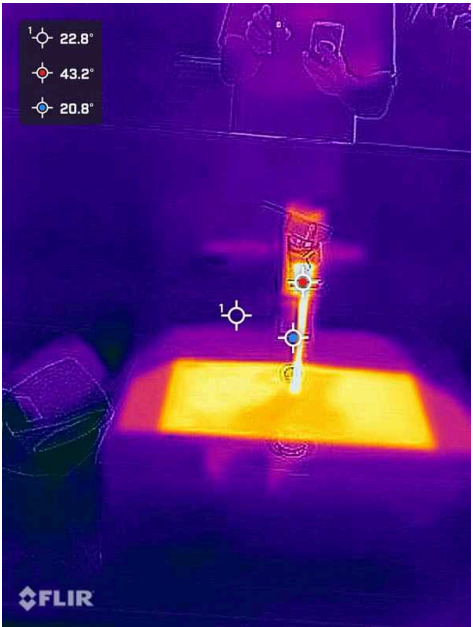
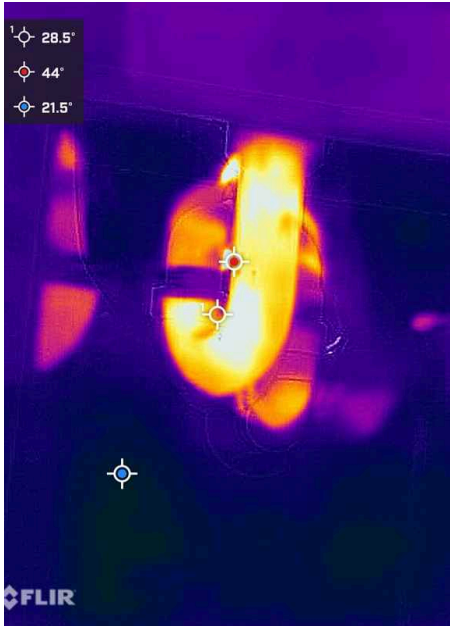
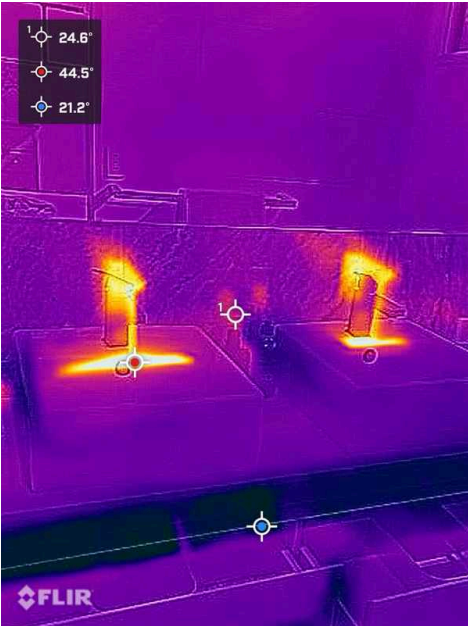
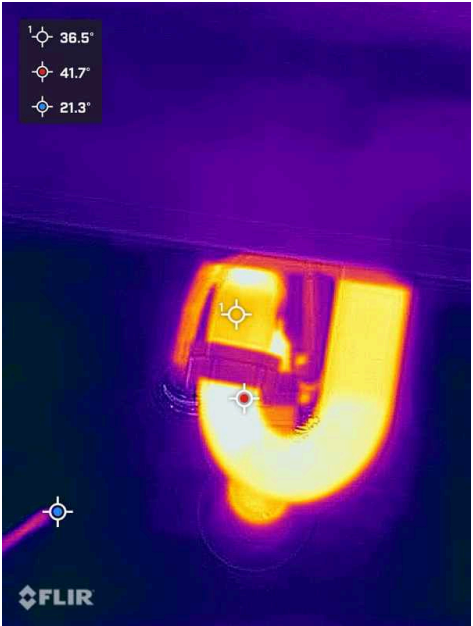
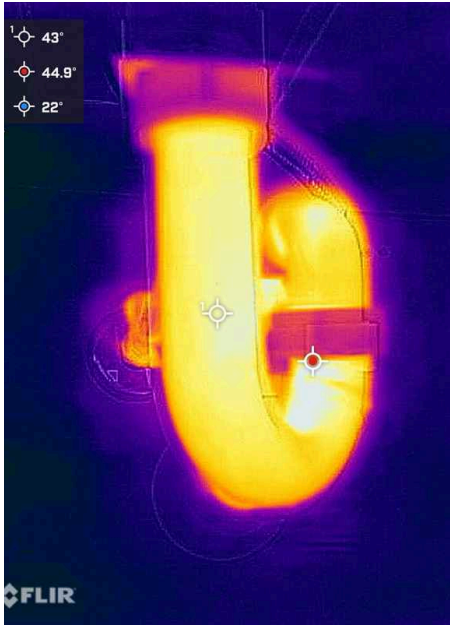
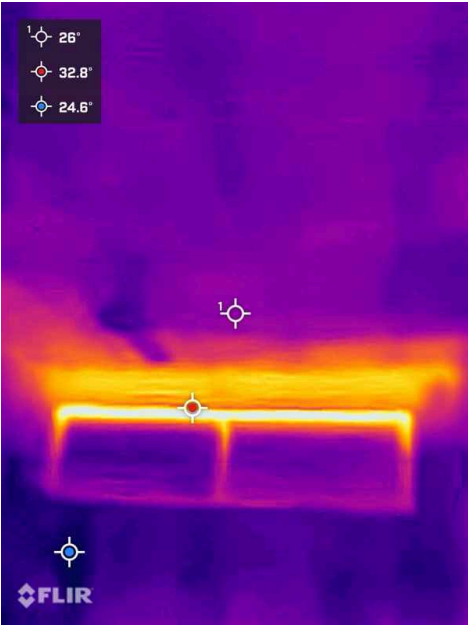
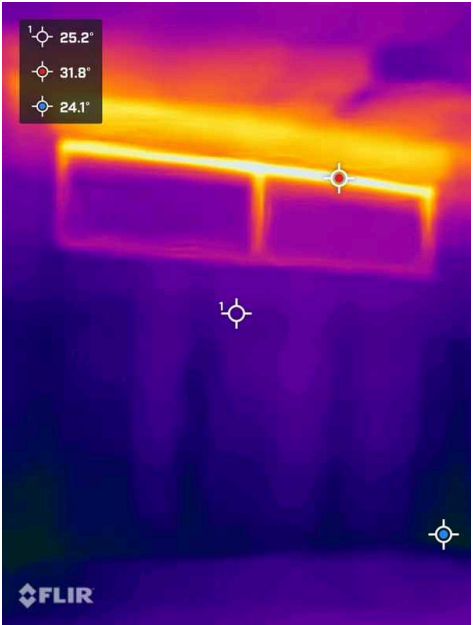
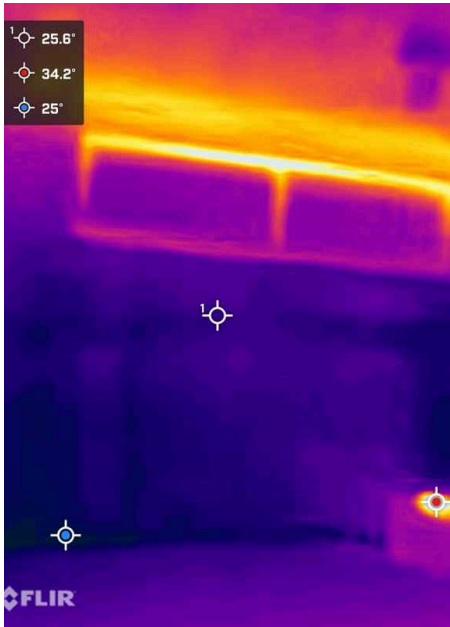
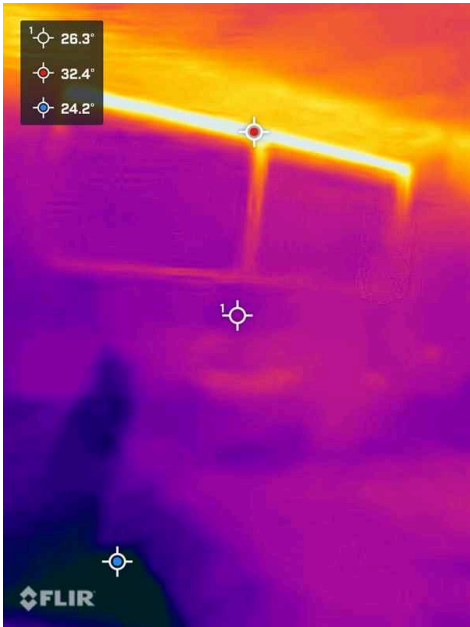
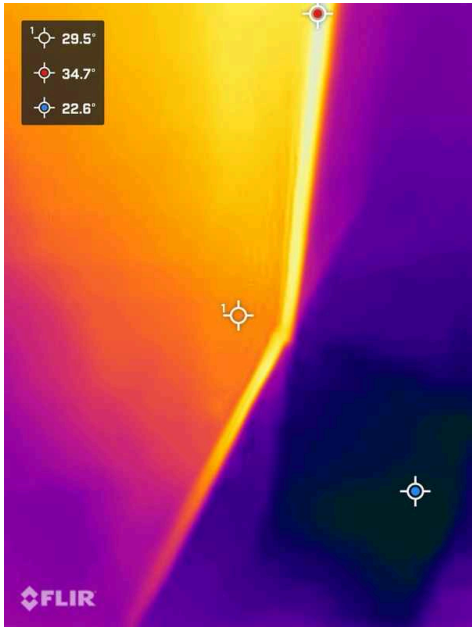
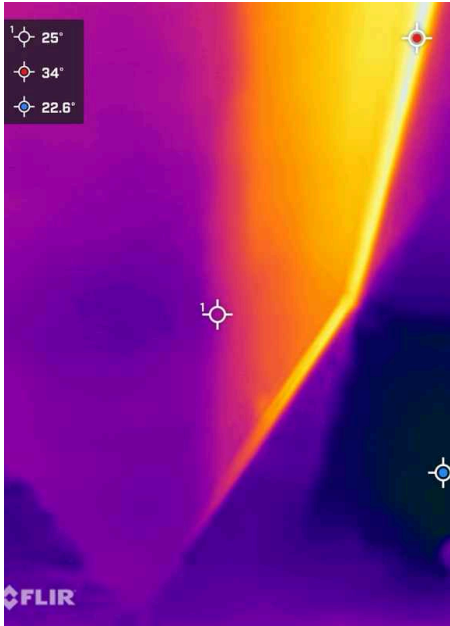
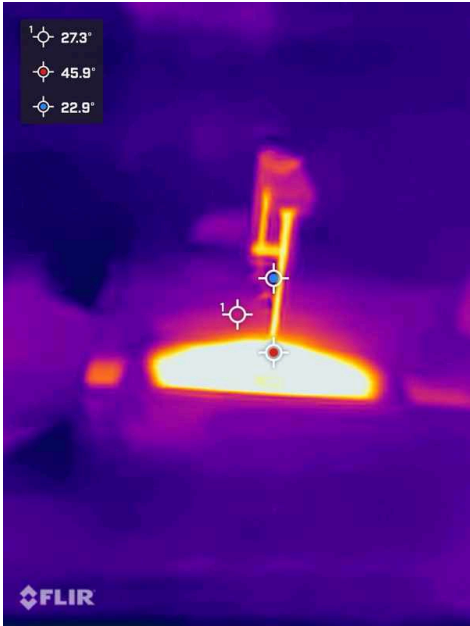
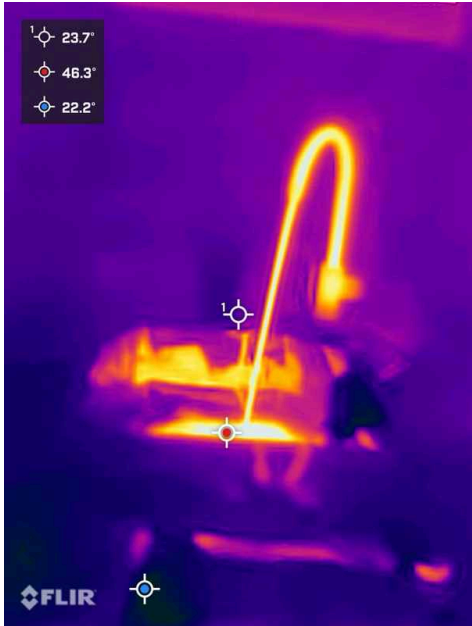
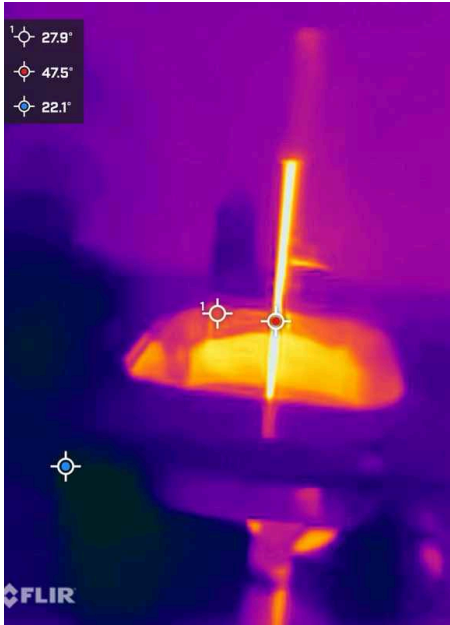
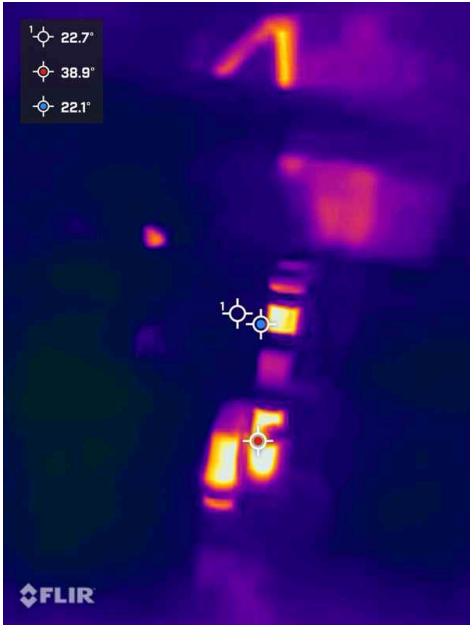
## Moisture and Thermal Inspection Photos

Moisture meter readings and thermal imaging were performed during the inspection and did not reveal elevated moisture levels or abnormal thermal patterns at the time of assessment. These diagnostic tools help identify potential hidden issues such as water intrusion/ leaks and deficiencies that may not be visible to the naked eye.
